Raba-Kistner Consultants, Inc.
12821 W. Golden Lane
P.O. Box 690287, San Antonio, TX 78269-0287
(210) 699-9090 • FAX (210) 699-6426
www.rkci.com

Project No. ASF02-094-00
February 22, 2002

Re: Environmental Overview
15.57 Acre San Angelo Incinerator/Dump Site
U. S. 67 and Sherwood Way
San Angelo, Texas

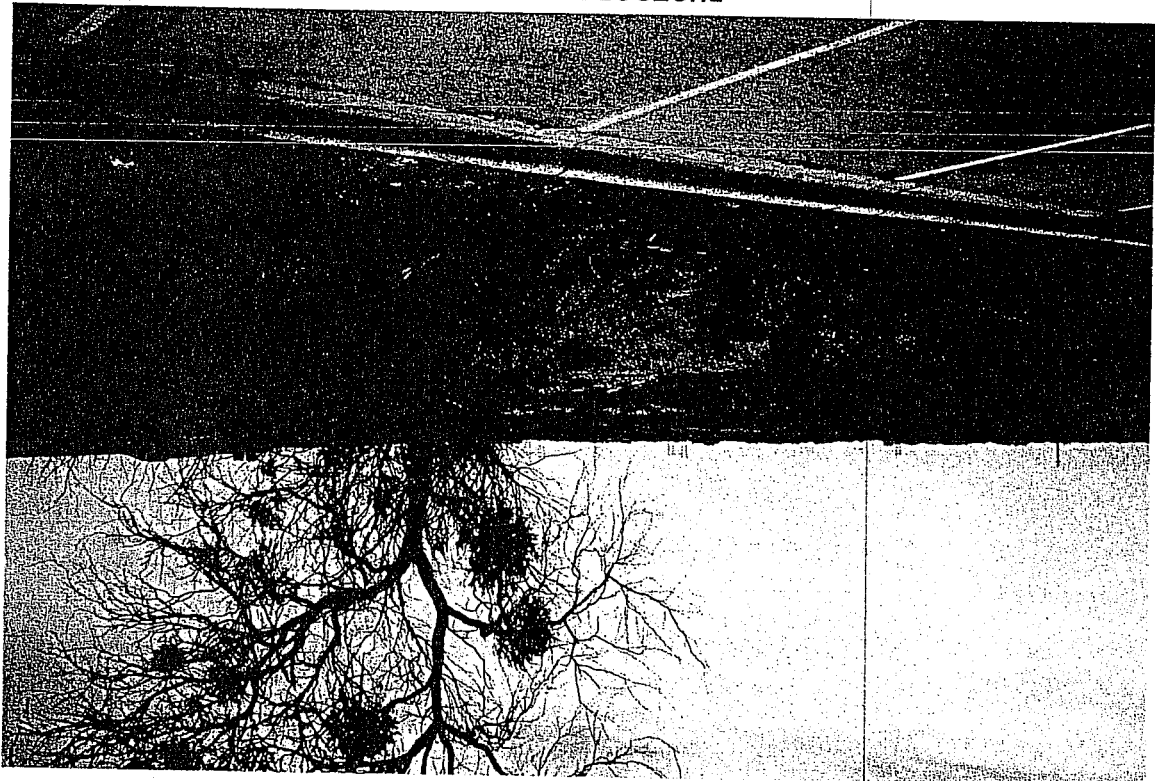
PHOTOGRAPH NO. 5
VIEW FROM NORTHEAST CORNER OF SITE - FACING SOUTHWEST - ACROSS SITE.
PHOTOGRAPH TAKEN BY R-K ON 2/15/02.
