Twin Buttes Transportation Management Plan

San Angelo Project, Twin Buttes Reservoir, Texas

September 2019

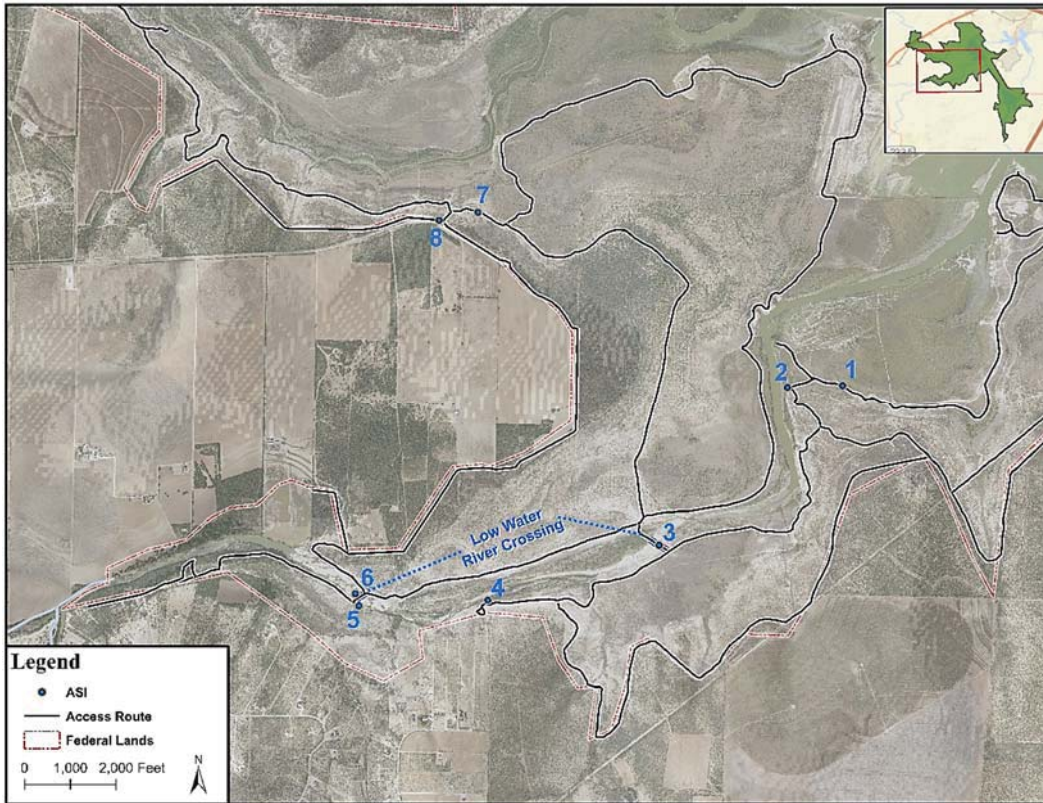
Figure 2. Access Routes – Areas of Special Interest (only access routes with an ASI shown)

ASI ID #	Observed Conditions	Managerial Considerations
1	Muddy Area/Rutting	Monitor to ensure stability of the area, as it may continue to degrade; potential seasonal restriction to avoid degradation during wet periods
2	Rocky climb	Monitor to ensure effective route closure; widen the route turn, reduce the route gradient and/or harden the route gravel
3	River crossing	Monitor approaches into the crossing; harden the route gravel
4	Muddy Area/Rutting	Monitor to ensure the route does not migrate
5	Bank Erosion	Monitor and evaluate stability of the area, as it may continue to degrade
6	Multiple River Crossing	Consolidate and/or harden route to avoid further degradation
7	Muddy Area/Rutting	Monitor to ensure stability of the area, as it may continue to degrade; potential seasonal restriction to avoid degradation during wet periods
8	Muddy Area/Rutting	Monitor to ensure stability of the area, as it may continue to degrade; potential seasonal restriction to avoid degradation during wet periods

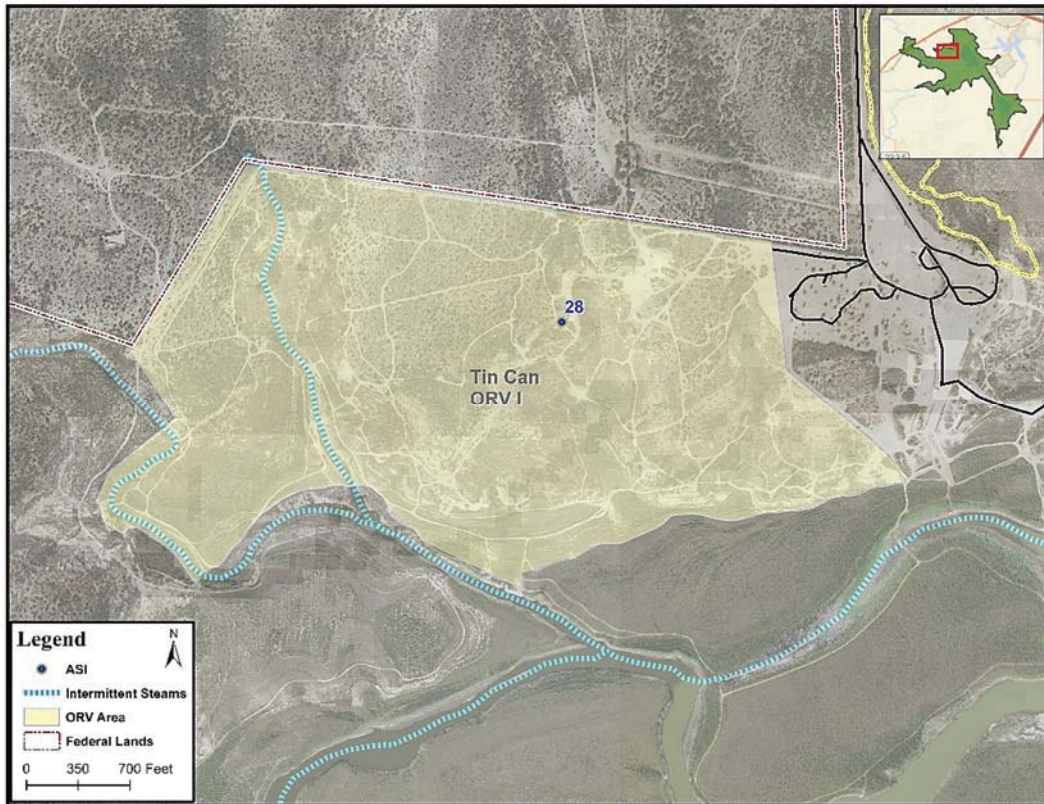
Figure 4. Tin Can ORV Area – Areas of Special Interest

ASI ID #	Observed Conditions	Management Considerations
28	Muddy Area/Rutting	Monitor to ensure stability of the area, as it may continue to degrade; potential seasonal restrictions to avoid degradation during wet periods

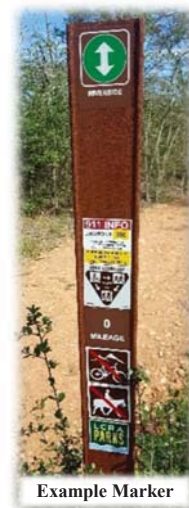
Example Marker

- “ATV and Motorcycle” routes may be marked with standard ATV symbol decals, indicating that the route is closed to full size vehicles.
 - The boundaries of the 4-wheel drive/ORV areas may be marked with “entering” and “leaving” designated area decals.

- Routes closed may be marked with “No Motor Vehicle” or “Route Closed” decals with standard vehicle symbols, as deemed necessary. As closed routes heal through natural re-vegetation or reclamation efforts, and markers are no longer necessary, they may be removed. Closed route markers may remain in place as necessary for resource protection or public safety.

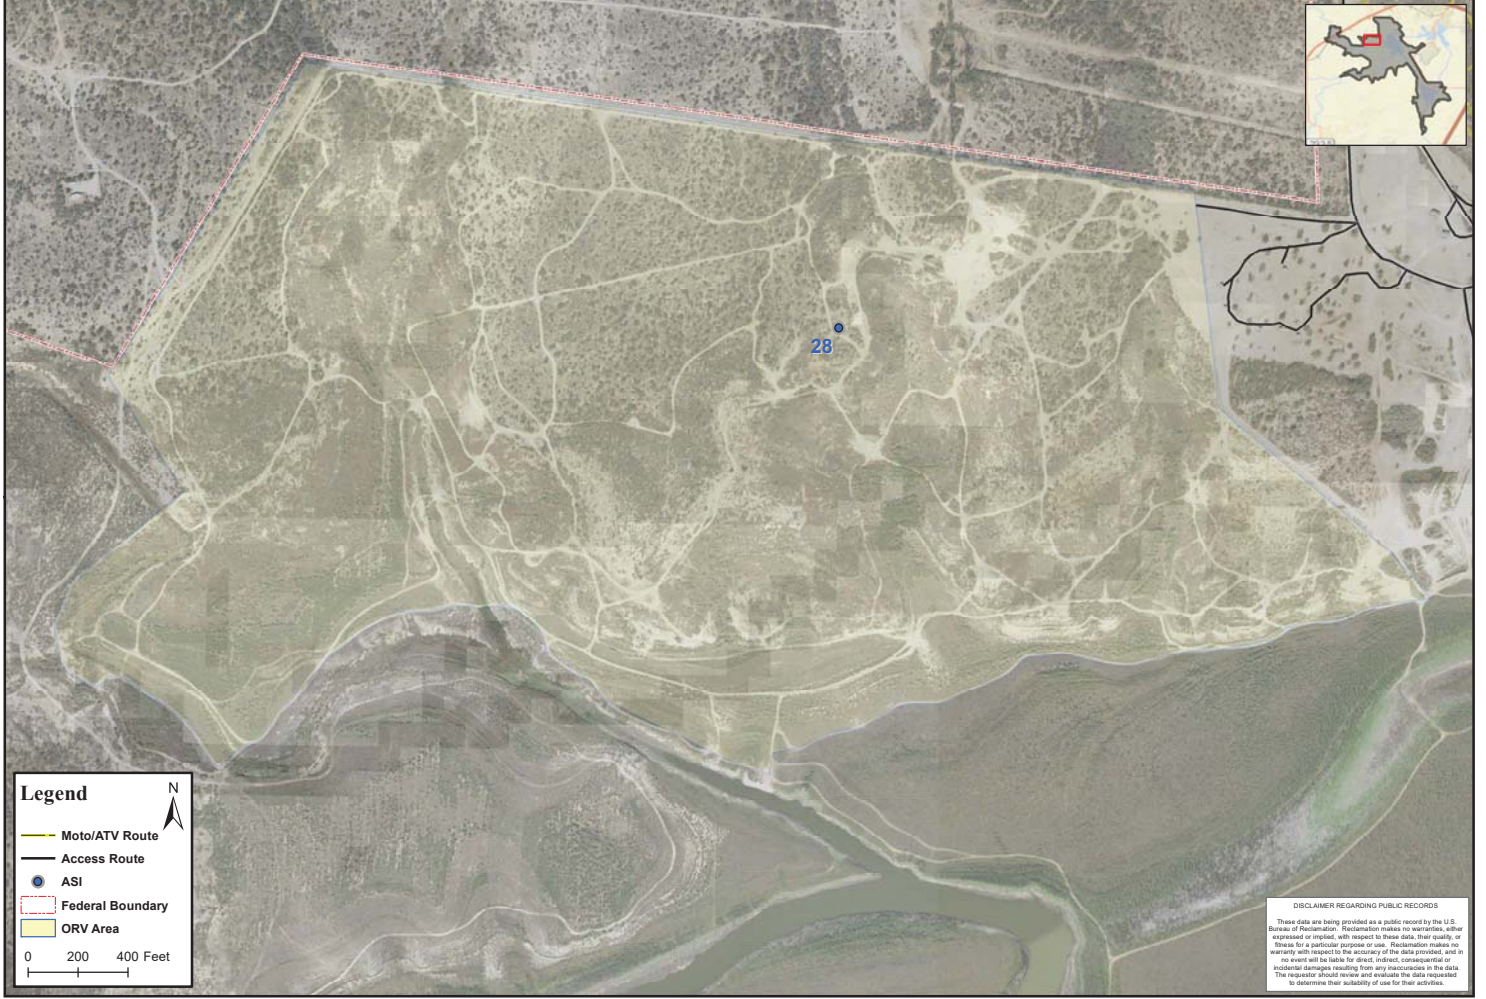
FIGURE B-1
DETAILED MAPS

NORTH POOL
ASIS

ASI ID #	Observed Conditions	Management Considerations
9	Head Cut Erosion	Monitor the progression of the head cut; further evaluation may be required
10	Gully Erosion	Monitor to ensure the gully does not expand
11	Gully Erosion	Monitor to ensure the gully does not expand

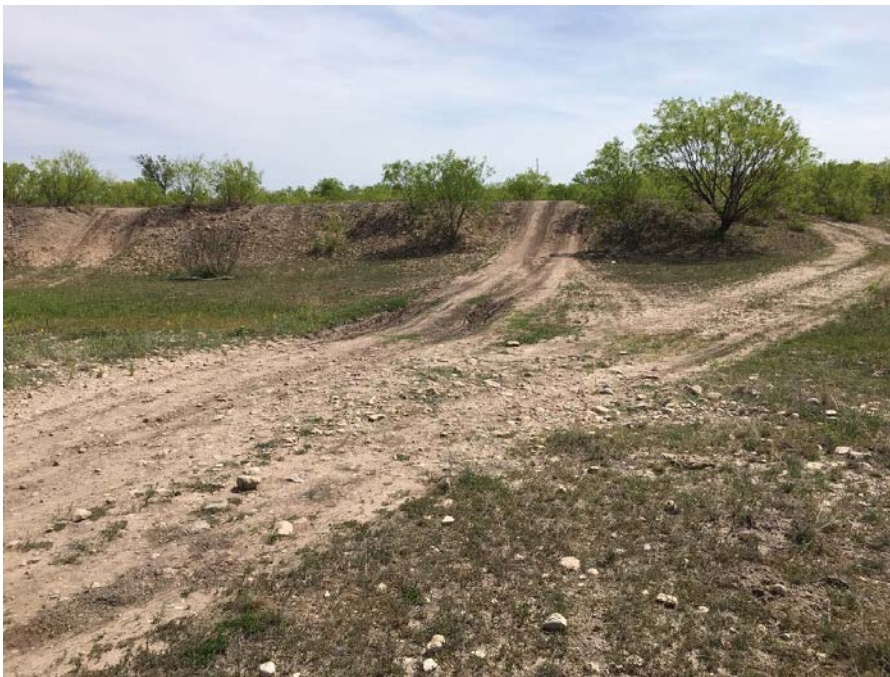
Users have selected several main crossings based on natural, existing conditions, such as hardened rock bottom and constrained flow. One of the main concerns is duplicate approaches into these crossings. Consolidating these to one approach on each side of the crossing will reduce erosion and sedimentation into the reservoir. Signage, barriers, and route hardening can all help define the preferred approach and reduce future maintenance.

Multiple, unnecessary approaches

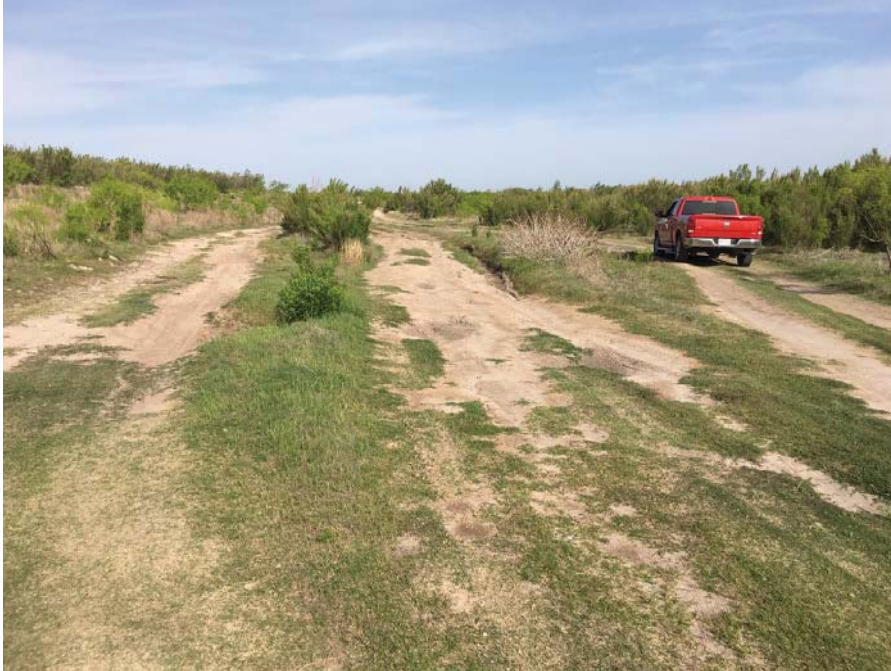
When the main route becomes wet and rutted, users will also attempt to bypass the existing route in search of an easier path. This creates multiple or widened routes, creating more resource damage than is needed to effectively provide access. Hardening the preferred route and potentially restricting access provides a reliable route from which users won't deviate.

Unnecessarily wide route

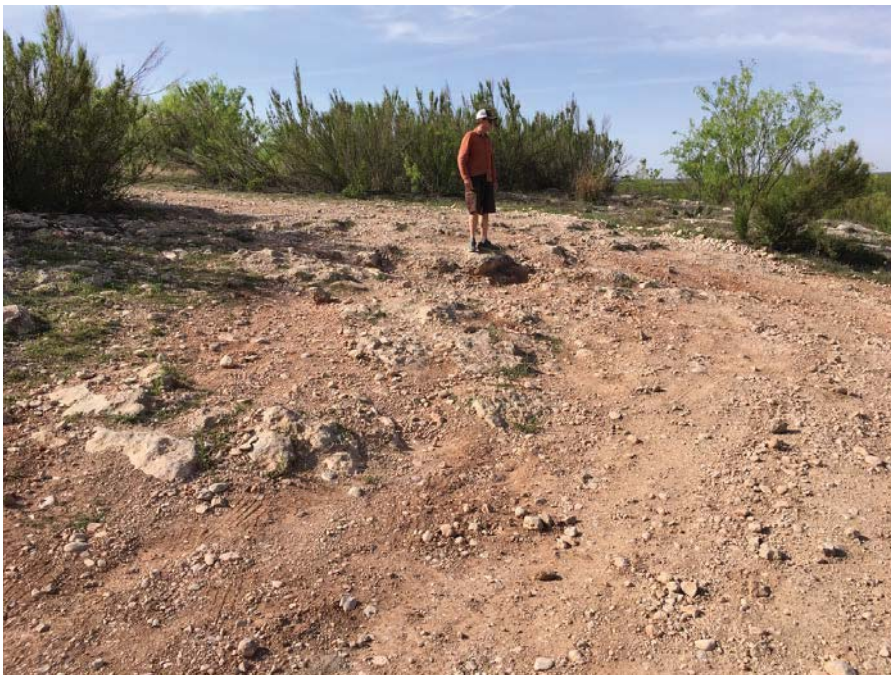
Steep route depositing material directly into reservoir

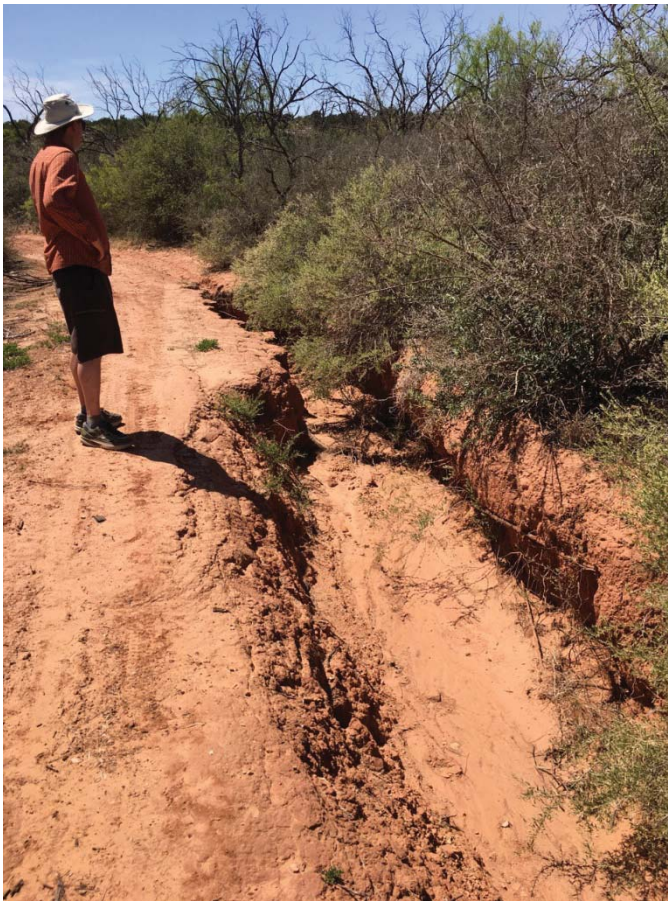
Ruts and rills can lead to an incised route

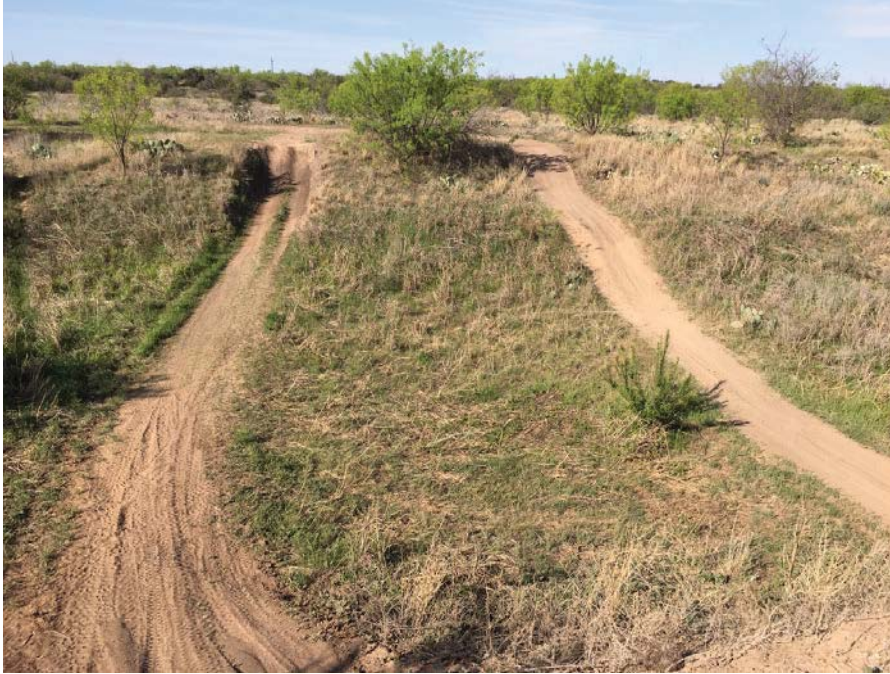
The motorcycle loop crosses the same channel in quite a few locations. Even channels that are dry for most of the year concentrate storm water flows, and have greater potential for erosion and sedimentation. Users have created more crossings than currently designated and are using them as large jumps. Once again, maintaining the current or a lower density of trail crossings will be essential in preventing excessive erosion and sedimentation, as well as with unauthorized expansion. Focusing preventative maintenance techniques, such as identifying proper crossing locations and approach hardening, on authorized routes will not only help with resource damage, but also with maintaining a safe travel system.

Multiple channel crossings in motorcycle trail area

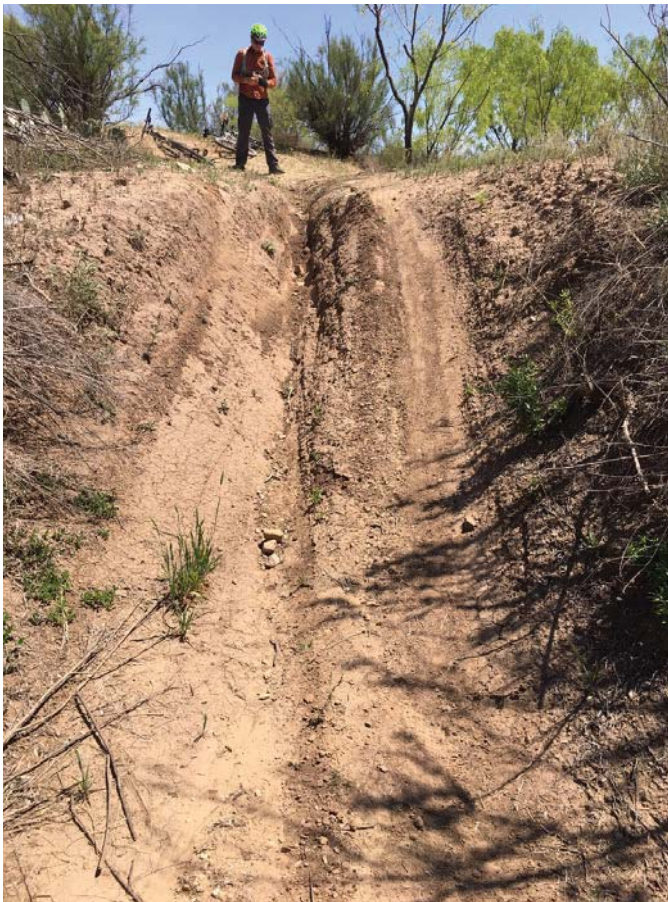
Eroded approach into channel in motorcycle trail area

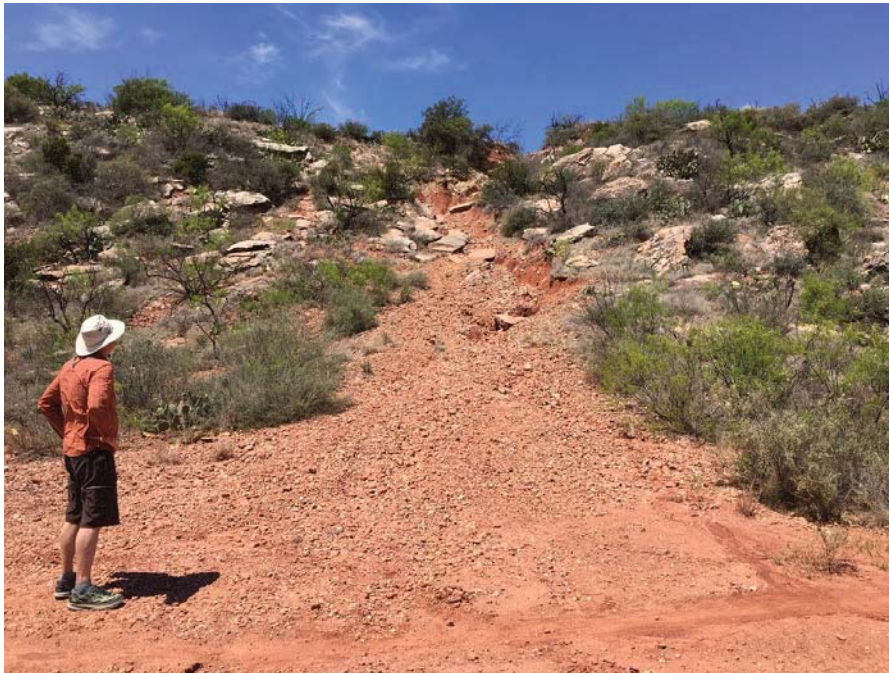
- *Hillside erosion:*
Maintaining sustainable rock crawler routes is always a challenge. A small amount of erosion must be accepted, but also balanced with a low level of routine maintenance. Once material has eroded from a crawler slope, it can be extremely difficult to recover. Besides losing material from the actual route, eroded material can also be deposited onto main access routes, plugging drainage features and making them impassable. In order to achieve an acceptable level of stability, features like check dams or grade breaks must be implemented.

Alluvial deposit from eroded crawler trails in “The Bowl”

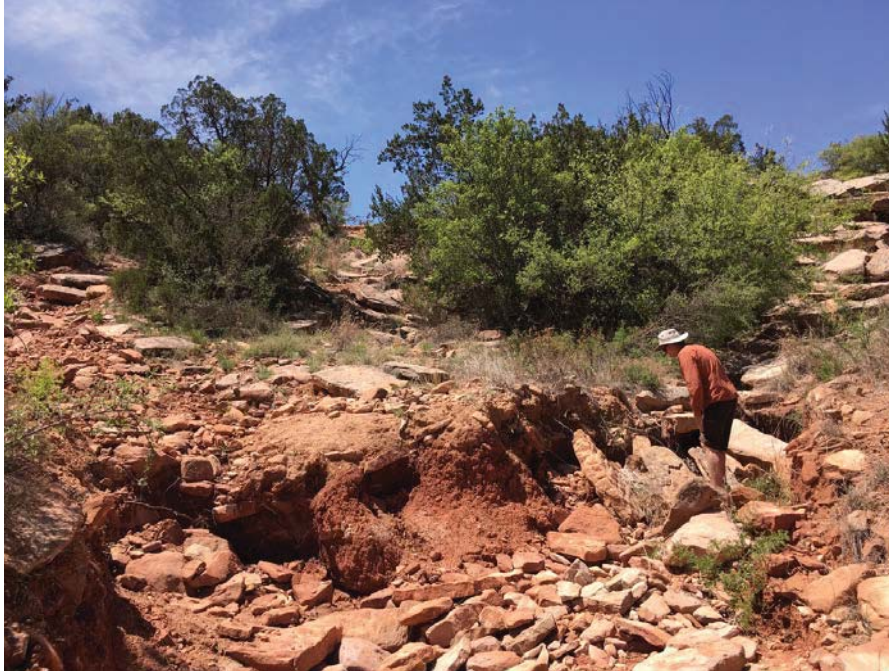
Heavy erosion in “The Bowl”

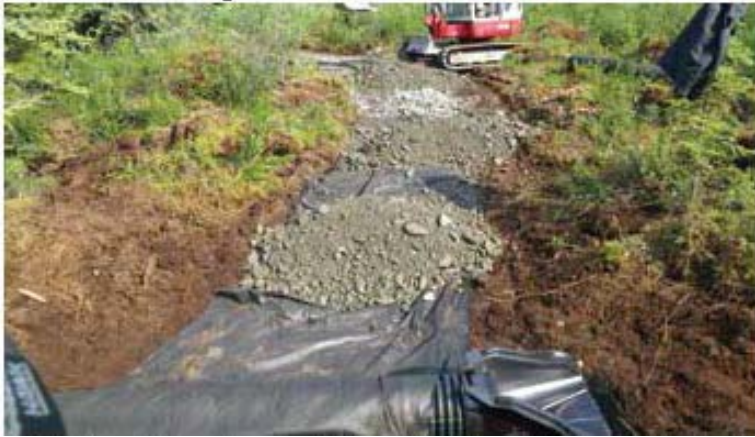
In chronically wet areas, fabric can be used to contain dry, compacted material. This is an initially expensive treatment, but will keep users on one route and reduce long-term maintenance costs.

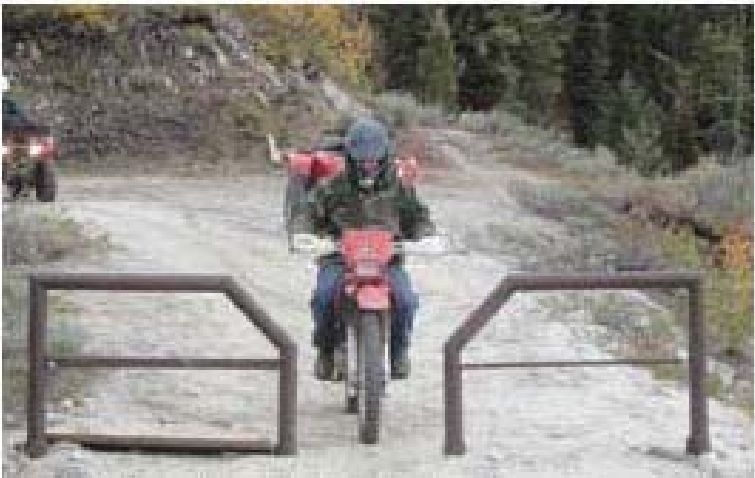
Constricted entrances can be used to control the width of vehicles allowed in the route system.

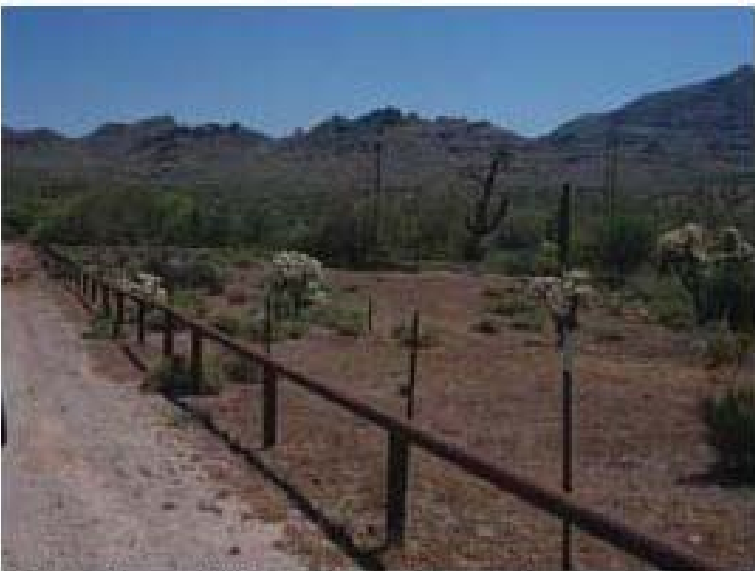
Pipe-rail fencing is an inexpensive tool to close areas to users.
